**SUBJECT: Executive Summary of Rainbow Terrace Investigative Efforts**

The investigation into the tragic incident that occurred on June 23, 2025, at Rainbow Terrace Apartments has been finalized.

The evidence does not establish the source of the gas release or the heat source that ignited it to the degree of certainty required under NFPA 921; accordingly, FIU classified the cause of the fire and explosion as **Undetermined**.

S-E-A, Ltd. did not reach a conclusion regarding the origin and cause of the explosion. However, **Enbridge concluded that the “apparent cause” of the explosion was ignition of leaking gas from the building owned 2” house line gas piping.**

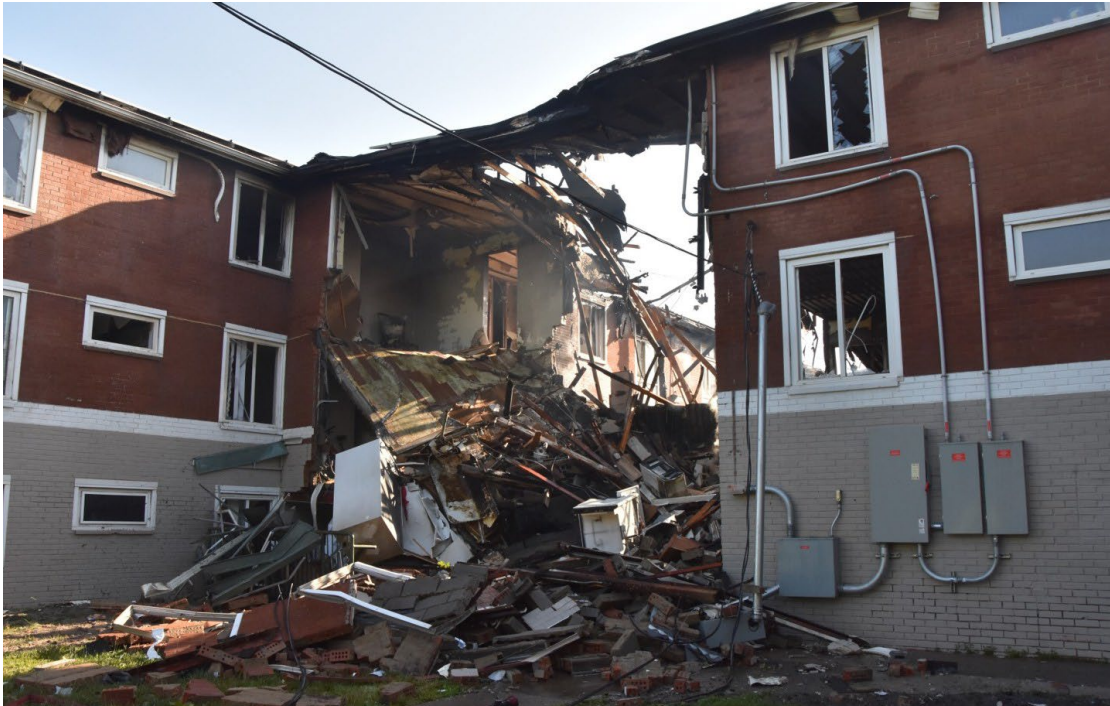
**Figure 3:** Explosion area viewed from the south, looking north.

S-E-A arrived at the site at approximately 7:45 p.m. (3½ hours after the incident). Firefighting activities were still ongoing at that time. The building was three stories (first floor, second floor, third floor) with the first floor partially below grade. The building had a brick exterior and an asphalt shingle roof. The explosion area of origin appeared to be the first-floor utility room and/or a second-floor apartment directly above the utility room. The explosion area of origin is

shown in **Figure 3**, with the photograph taken from the south, looking north. The explosion area of origin is shown in **Figure 4**, with the photograph taken from the north, looking south.

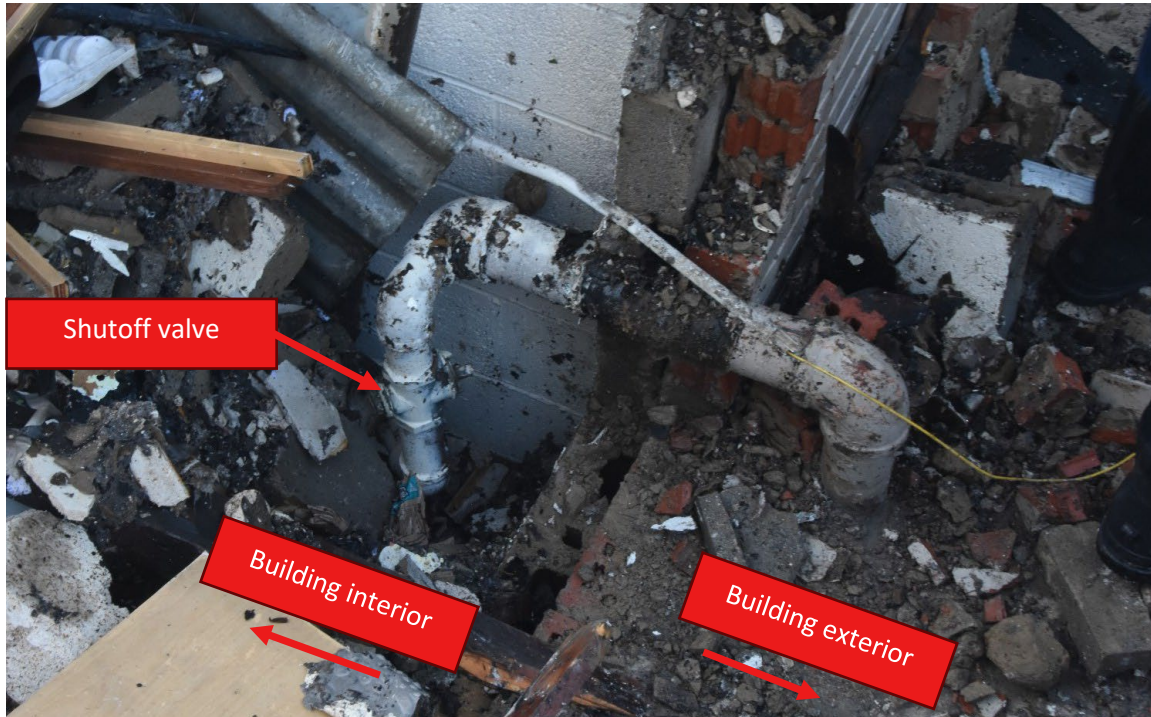
**Figure 6: South service line where it enters the subject building.**

Enbridge Gas personnel excavated the south service line where it connected to the south main, and where the south service line entered the south utility room (**Figure 6**). The below-grade horizontally-routed 3"-steel service line turned vertical approximately 6" from the outside wall, went to above-grade, turned horizontal, and penetrated the building's exterior brick and block wall approximately 6"-above grade. The south gas meter, which is not visible in Figure 6, was downstream of the service line piping shown.

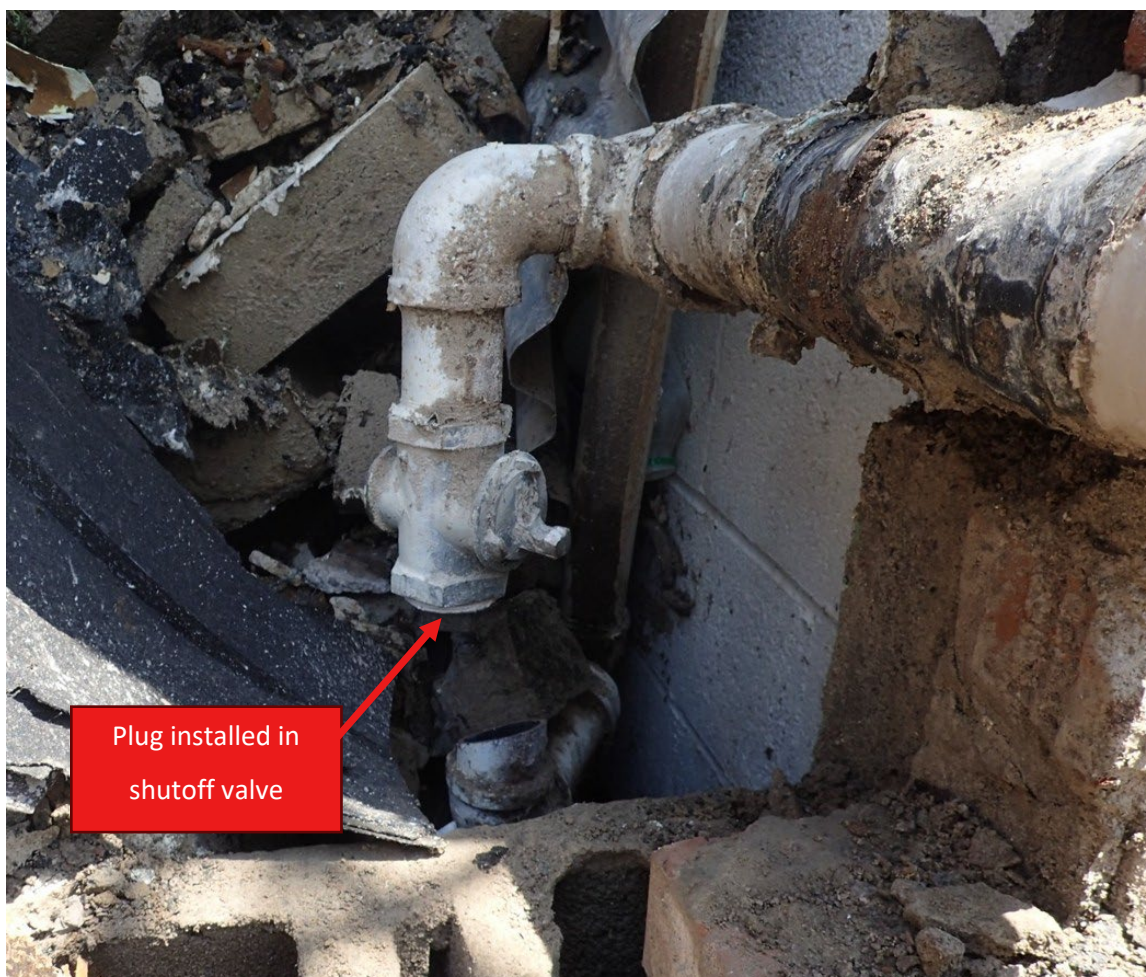
The south service line was cut, near its connection to the south main (approximately 90 feet south of the explosion area of origin), so that a leak test could be performed. Initially, an attempt was made to close the shutoff valve shown in Figure 6, such that the south service line could be tested up to the closed shutoff valve; however, the handle of the shutoff valve fractured before the valve could be closed completely. Instead, the 2"-steel pipe nipple downstream of the shutoff valve was cut, the cut nipple was unthreaded from the shutoff valve, and a pipe plug was installed on the downstream side of the shutoff valve to facilitate a leak test, **Figure 7**.

**Figure 7: Pressure drop test #1, on June 24, 2025, at south service line, against plug on downstream side of shutoff valve.**

Enbridge Gas personnel connected pressurized air at the south-end of the south service line and pressurized the south service line to approximately 7.1 ounces (i.e., slightly above operating pressure). Over the course of the leak test (normally 10 minutes), the pressure dropped from a starting pressure of 7.1 ounce to 6.0 ounce at approximately four minutes into the test, 5.0 ounce at approximately seven minutes into the test, and 4.3 ounce at ten minutes into the test.

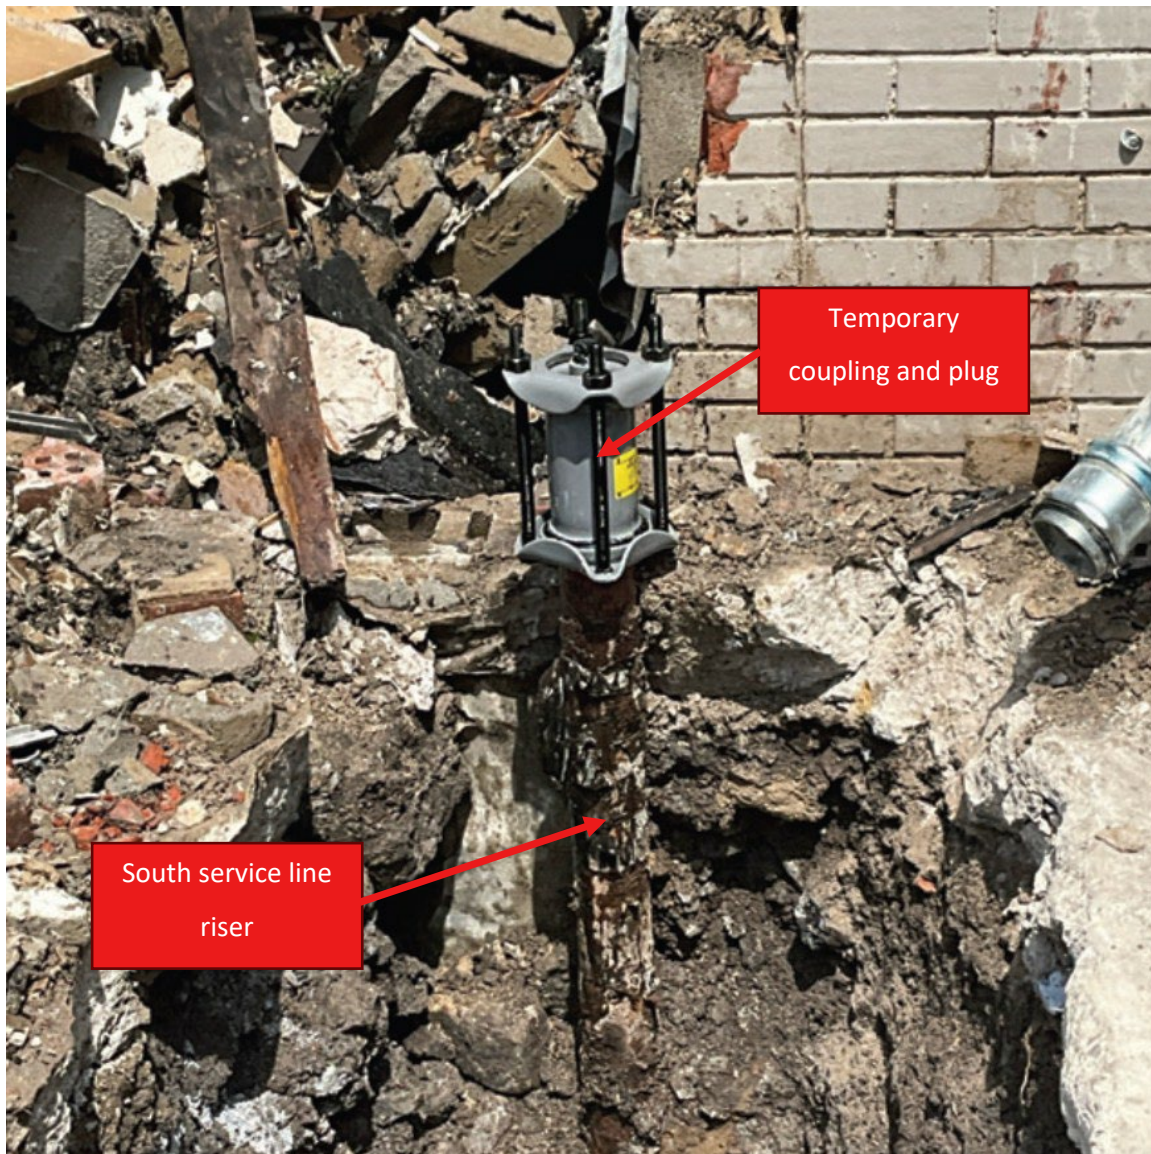
Enbridge Gas personnel then cut the south service line, just outside the exterior wall, such that a temporary coupling and plug could be installed, and a second leak test was performed, see

**Figure 8:** Pressure drop test #2, on June 24, 2025, at south service line, against coupling and plug on vertical riser, outside of building.

Enbridge Gas personnel connected pressurized air at the south-end of the south service line and pressurized the south service line to approximately 7.2 ounces (i.e., slightly above operating pressure). The pressure remained at 7.2 ounces for the duration of the 10-minute leak test, indicating no leak.

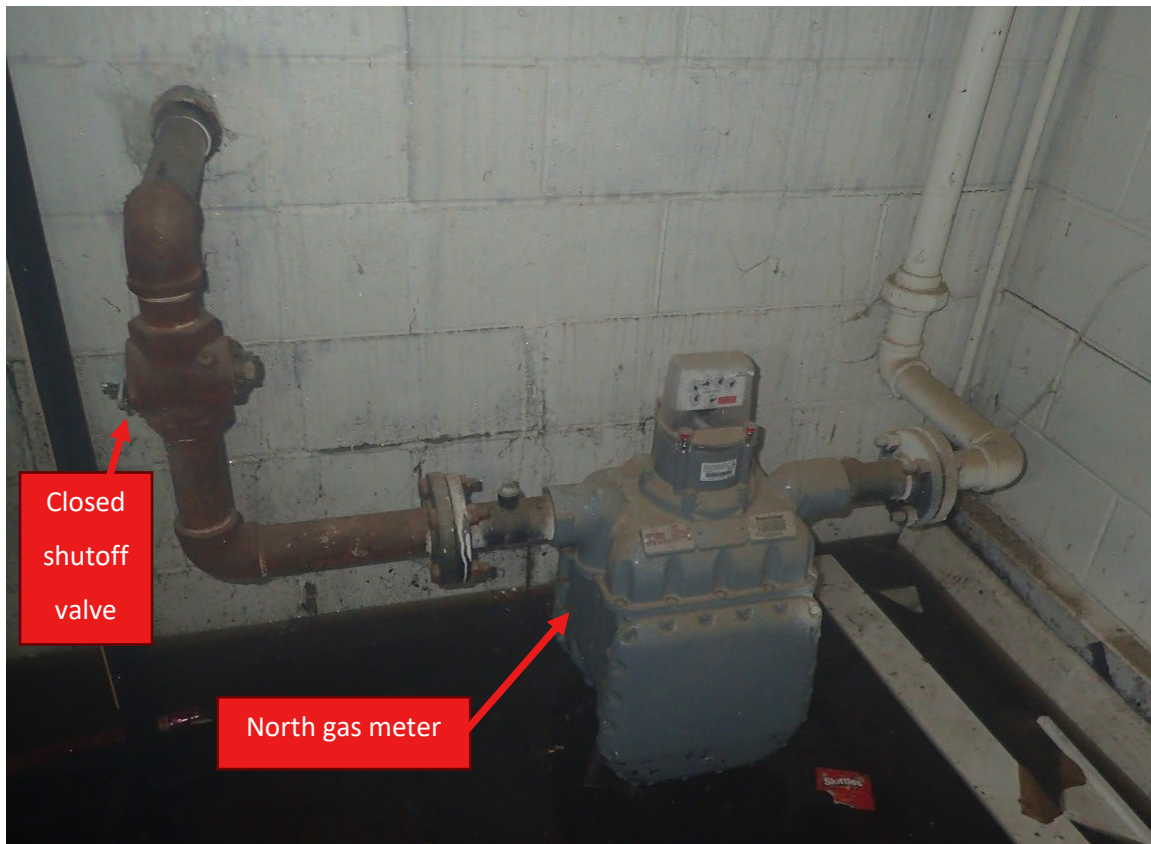
**Figure 9: North service line in northern utility room.**

Similarly, the north service line was excavated where it connected to the north main. As the northern side of the building was intact, Enbridge Gas personnel entered the northern utility room, removed the gas meter, and closed the shutoff valve upstream of the meter (**Figure 9**).

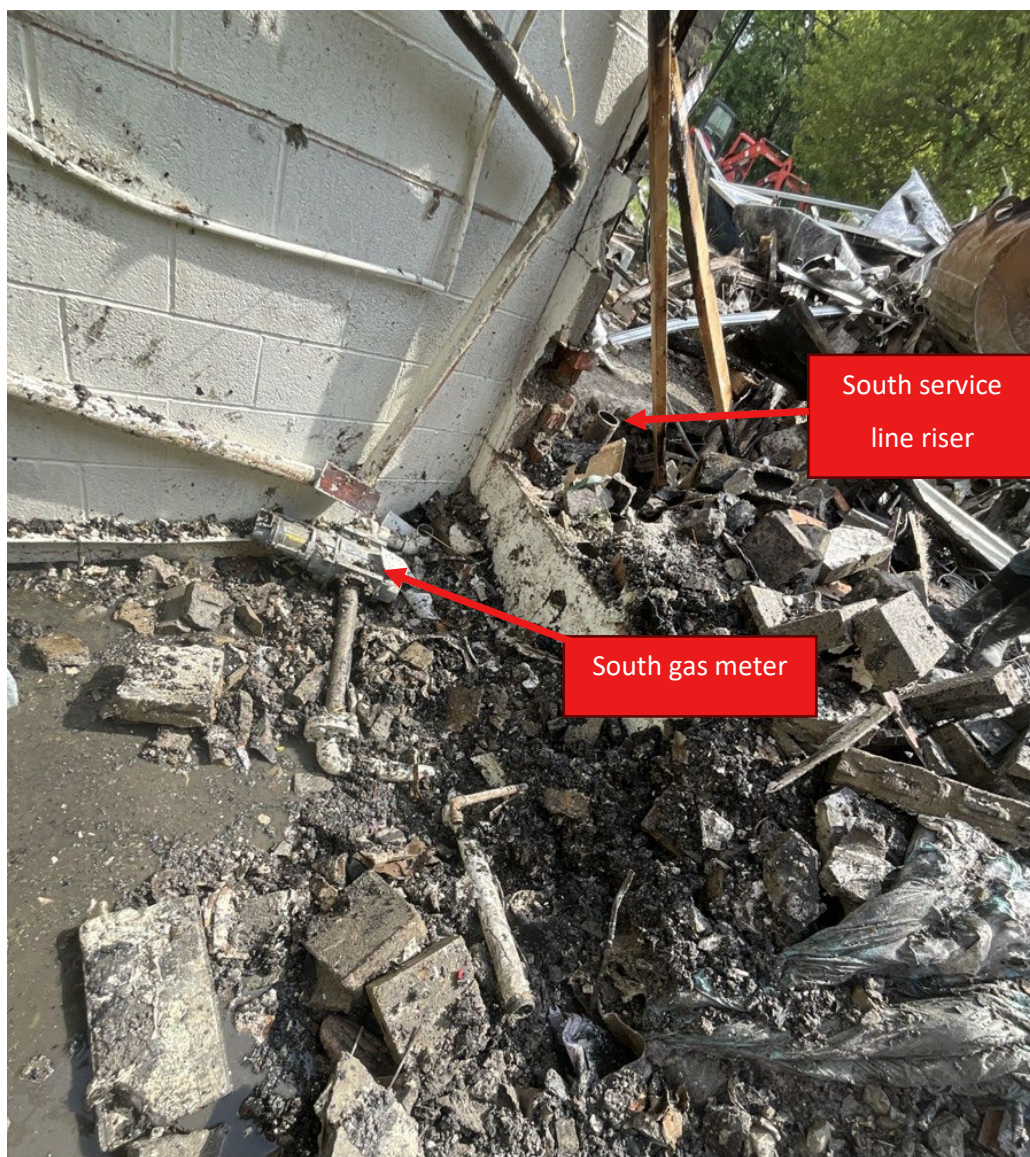
**Figure 10: South utility room and south gas meter.**

The City of Cleveland utilized an excavator to remove debris from the south utility room. The south gas meter and the attached upstream and downstream piping were discovered and collected (**Figure 10**). Several fractured segments of house line gas piping were observed in the area of the south utility room. Additional collection of the fractured piping segments was not performed on June 24, 2025, due to the unstable structure above.

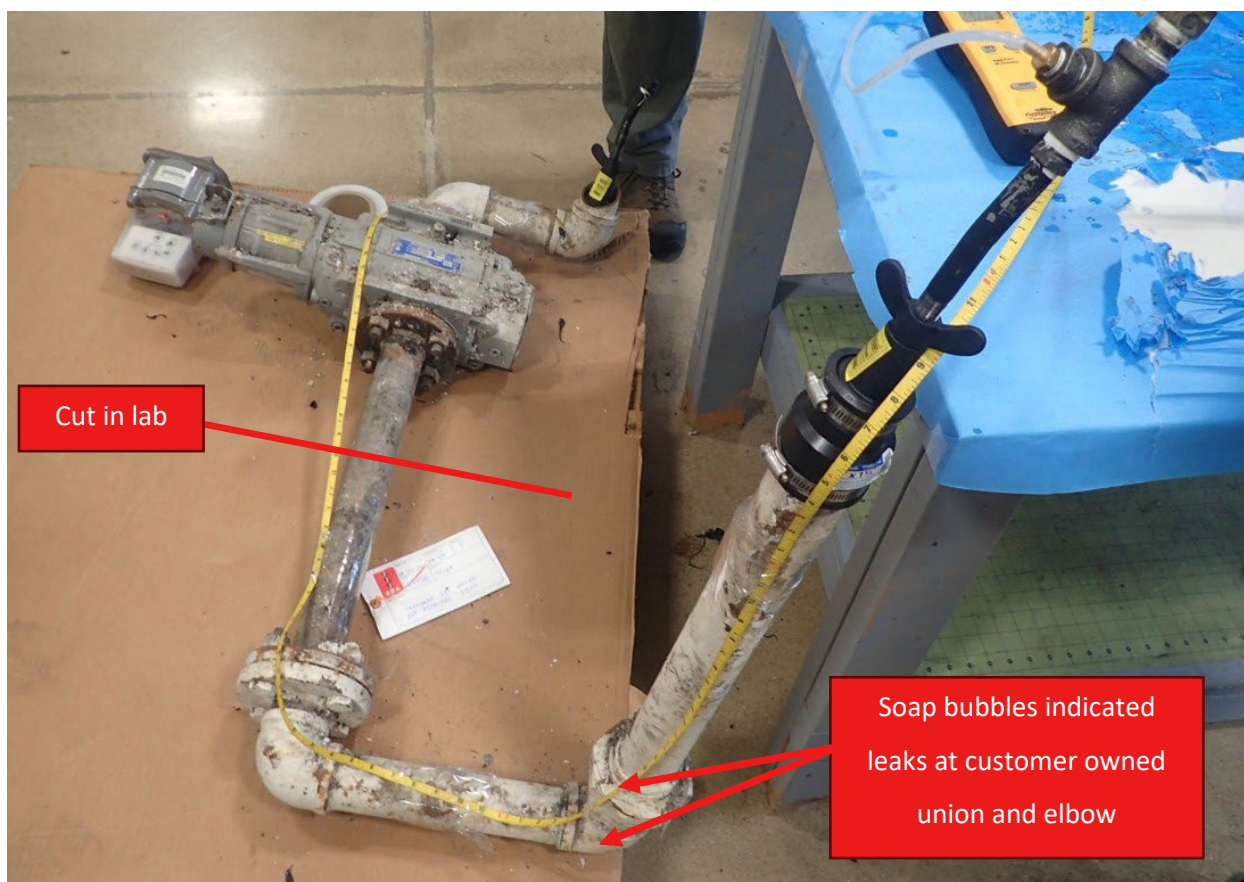
Figure 16: Evidence #5 - southern gas meter and attached piping.

- Evidence #5: Southern gas meter and attached piping
  - **Figure 16:** The evidence was pressurized to approximately 13.1" w.c. (7.6 ounces) and a Dwyer flow meter with a 0.6 to 5.0 SCFH scale was utilized to measure a leak rate. No observable leak rate was detected and the "bead" on the flow meter did not rise. The evidence was pressurized with air, then shut off from air, and it did not hold pressure, indicating a very small leak(s), less than 0.6 SCFH based on previous test with the flow meter. Leak detector solution was sprayed on the evidence, and active bubbling (indicating a leak) was present on the elbow and union downstream of the meter.
  - The piping was cut, just downstream of the gas meter, and the meter-side of the evidence held pressure and measured zero flow on a flow meter (i.e., no leak).

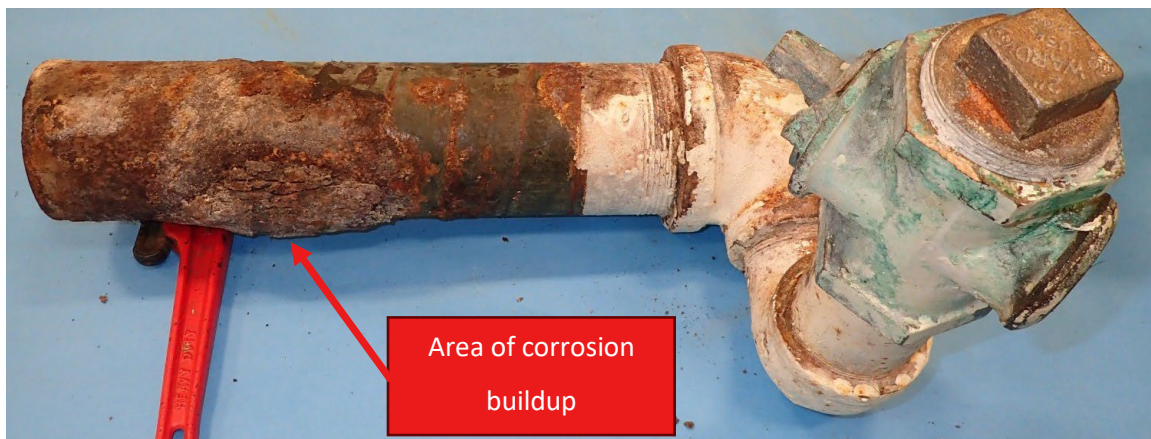
**Figure 17: Evidence #3 with black tape removed.**

The black tape that was wrapped around the portion of the piping that penetrated the exterior wall was removed by hand (**Figure 17**). An accumulation of corrosion product was observed beneath the tape. Removal of the corrosion product found that the pipe wall had thinned almost completely beneath this corrosion product. The corrosion product was voluminous and had caused the tape to bulge outwards, due to the change in volume of the pipe material as the corrosion occurred.

After removal of the black tape, a leak test was performed on Evidence #3, with the 0.1 to 1.0 SCFH flow meter, at approximately 13.1" w.c. (7.6 ounces). No observable leak rate was detected with the 0.1 to 1.0 SCFH flow meter and the "bead" on the flow meter did not rise.

After removal of the black tape, a pressure drop test was performed on Evidence #3, with a starting pressure of 12.94" w.c. After 5 minutes, pressure dropped to 12.48" w.c., indicating a very small leak, less than 0.1 SCFH, based on the previous test with the flow meter.

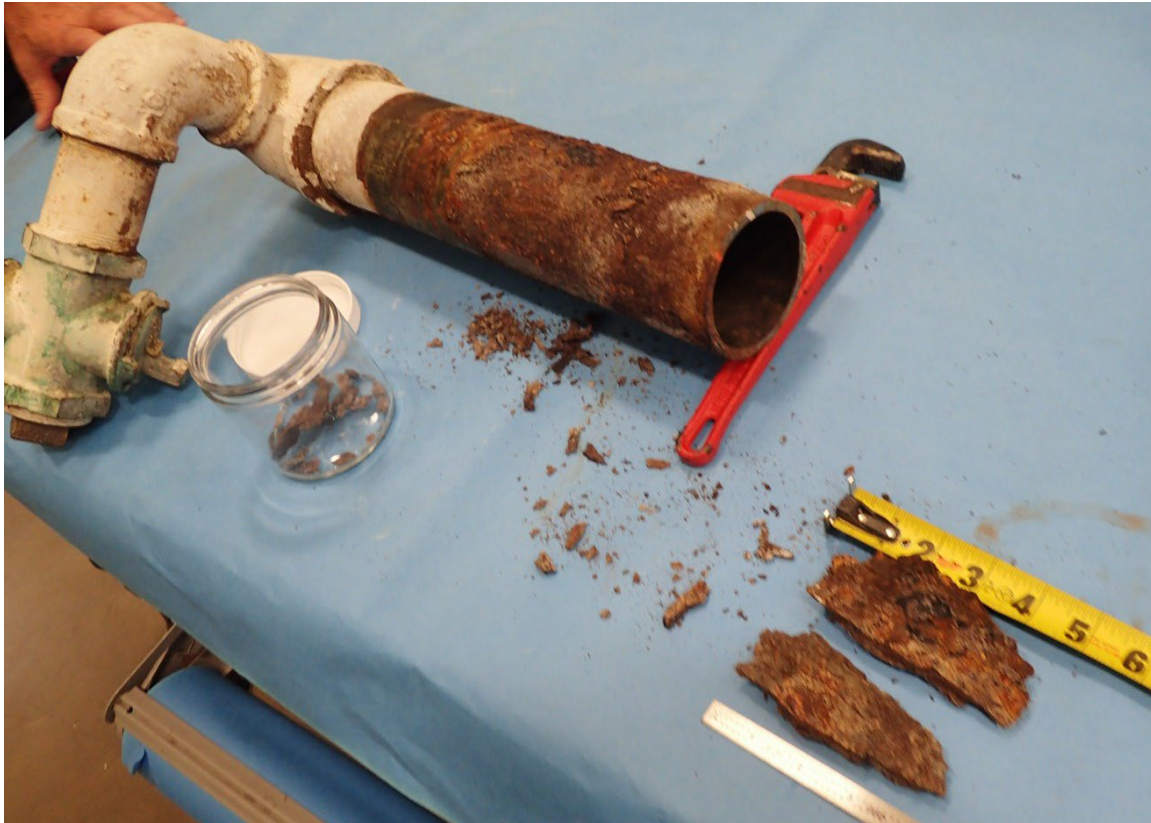
**Figure 18: Evidence #3 with corrosion buildup removed.**

The accumulated corrosion product was removed and preserved (**Figure 18**).

After removal of the corrosion buildup, a leak test was performed on Evidence #3, with the 0.1 to 1.0 SCFH flow meter, at approximately 13.6" w.c. (7.9 ounces). No observable leak rate was detected with the 0.1 to 1.0 SCFH flow meter and the "bead" on the flow meter did not rise. After removal of the corrosion buildup, a pressure drop test was performed on Evidence #3, with a starting pressure of 13.41" w.c. After 5 minutes, pressure dropped to 9.65" w.c.; after 10 minutes, pressure dropped to 3.08" w.c., indicating a very small leak, less than 0.1 SCFH based on the previous test with the flow meter. Evidence #3 was submerged in water and pressurized, and one bubble location was observed, beneath the previously removed corrosion buildup. Multiple cuts were made to Evidence #3 for additional metallurgical examination.

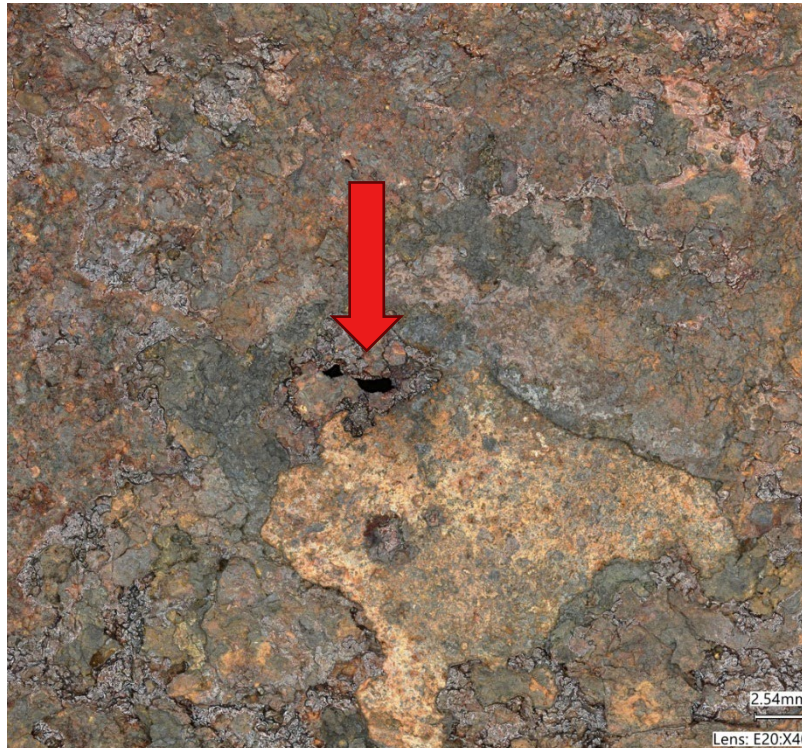
Digital microscope (Keyence) images of the pipe's exterior surface (**Figure 19**) and interior surface (**Figure 20**) in the areas of the leak are shown below. The larger of the two holes measured approximately 0.08" x 0.03", with an area of approximately 0.002 in<sup>2</sup>. The smaller of the two holes measures approximately 0.03" x 0.03", with an area of approximately 0.001 in<sup>2</sup>.

**Figure 19: Evidence #3 - pipe exterior surface in area of the leak.**

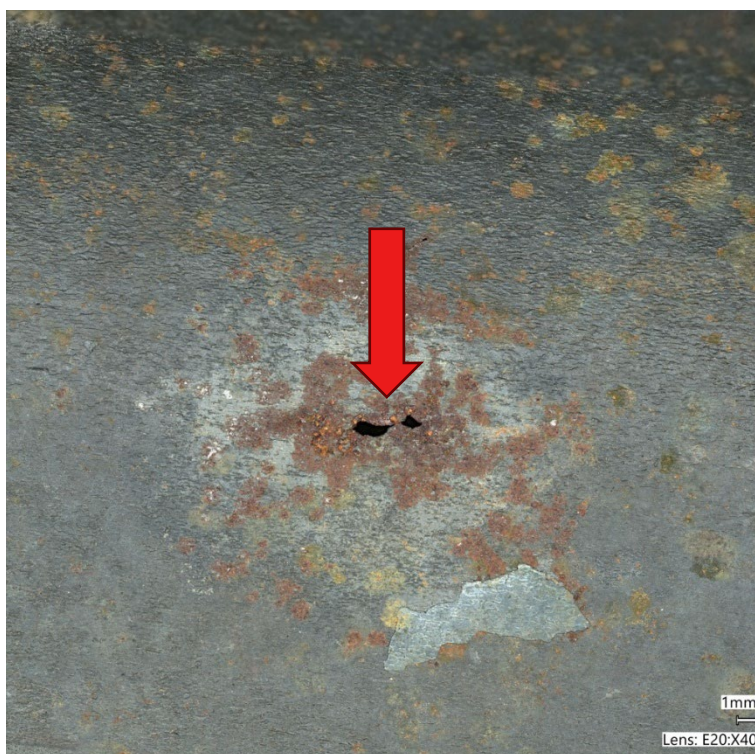
**Figure 20: Evidence #3 - pipe interior surface in area of the leak.**

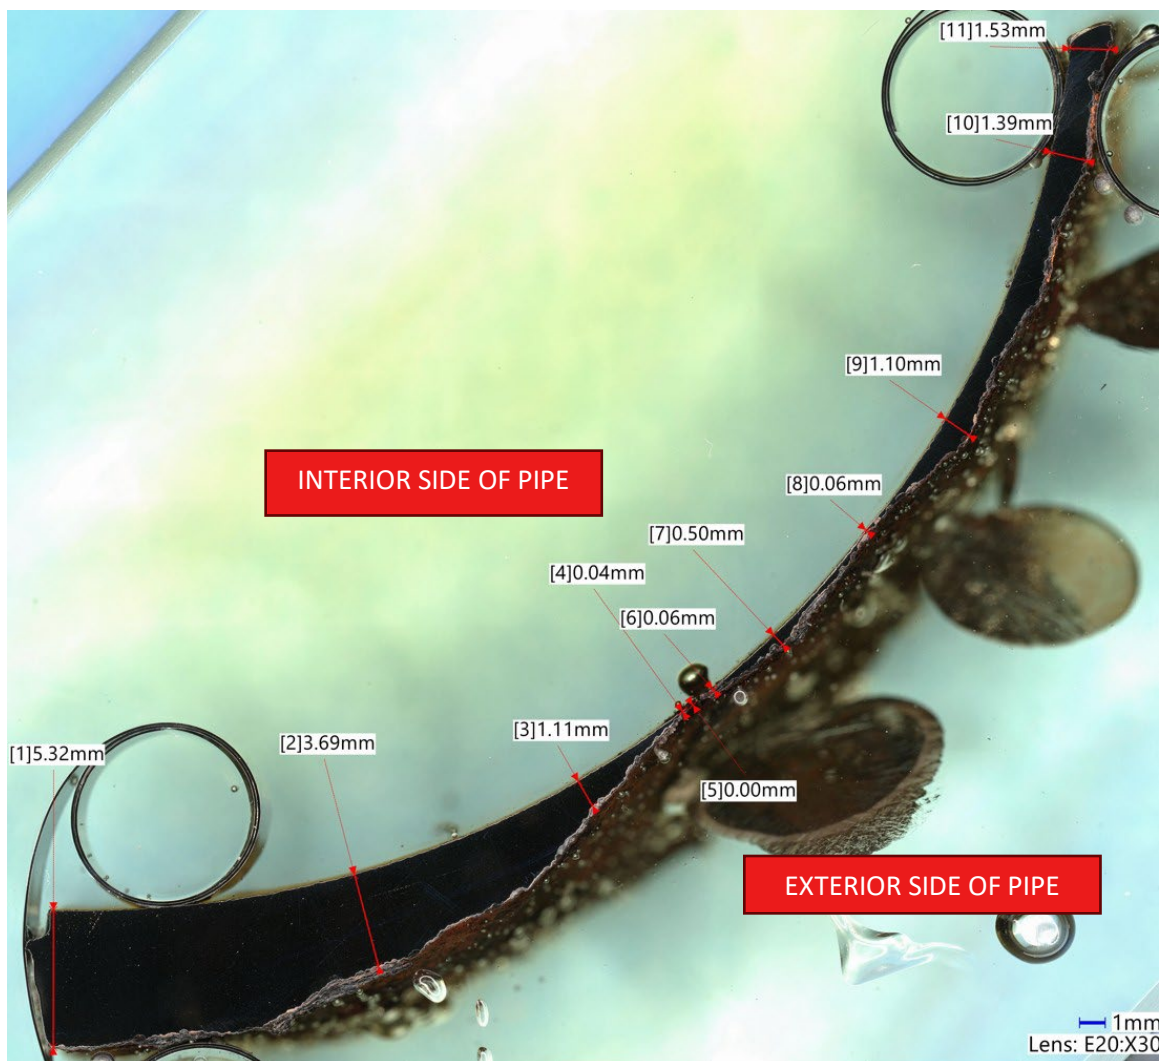
Wall thickness of the 3"-diameter pipe at the upstream end (not in the area of the corrosion) was measured with digital calipers at approximately 0.2290" (5.8166 mm). A cut was made through the pipe wall, near the location of the two holes shown in Figure 19 and Figure 20. A section of the pipe wall was mounted in two-part epoxy and prepared metallographically. The mounted section is shown in **Figure 21**. The shape of the corrosion, and condition of the inner surface versus the outer surface, indicates that the corrosion occurred outside-in. The pipe wall thickness was found to be thinned, as shown by the annotated measurements in Figure 21.

Figure 21: The pipe wall was found to be thinned in the area of the two holes.

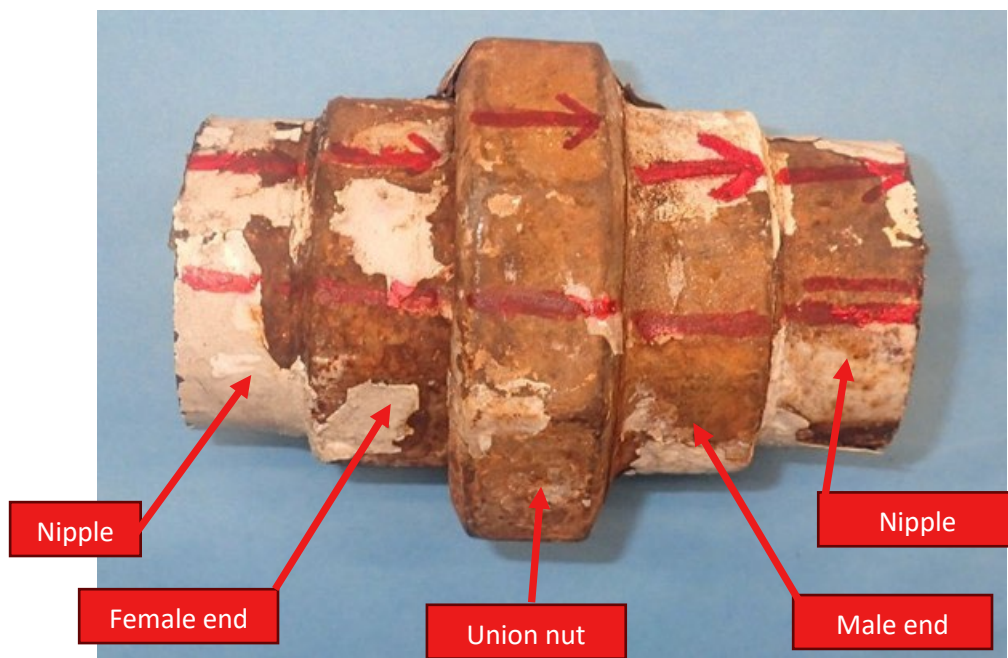
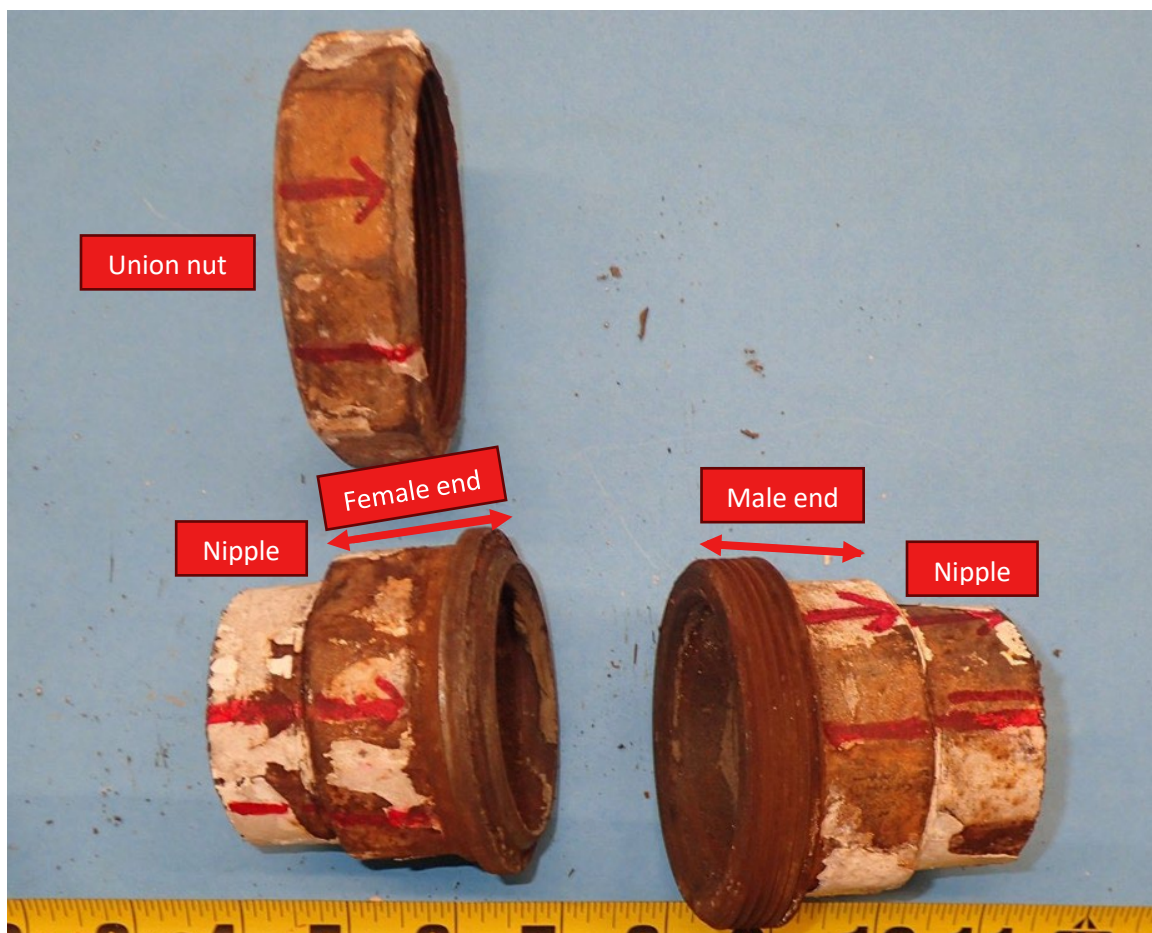
The 2"-diameter pipe nipples on the upstream and downstream side of the subject union were cut to permit further examination. The entire union was CT scanned intact to determine if the union nut threads were broken, either from post-incident building collapse, or from the explosion itself; however, the CT scan and subsequent disassembly revealed that all observable threads were intact.

Figure 24: 2"-diameter union, still assembled, from Evidence #15.

Figure 25: 2"-diameter union, disassembled, from Evidence #15.

Disassembly of the union revealed that the union nut was less than hand tight. It took five full rotations to disassemble the union nut, separating the two union halves. Threads on the union nut and male end were observed to be intact. Inspection of the mating surfaces of the male end and female end revealed that apparent pipe dope was used, likely during the original assembly, see **Figure 26** and **Figure 27**. Note, apparent pipe dope was also observed at the connection of the two union halves to the threaded pipe nipples, this was expected as pipe dope (or PTFE tape) should be applied to the threaded connections, but not at the mating surfaces of the union halves.

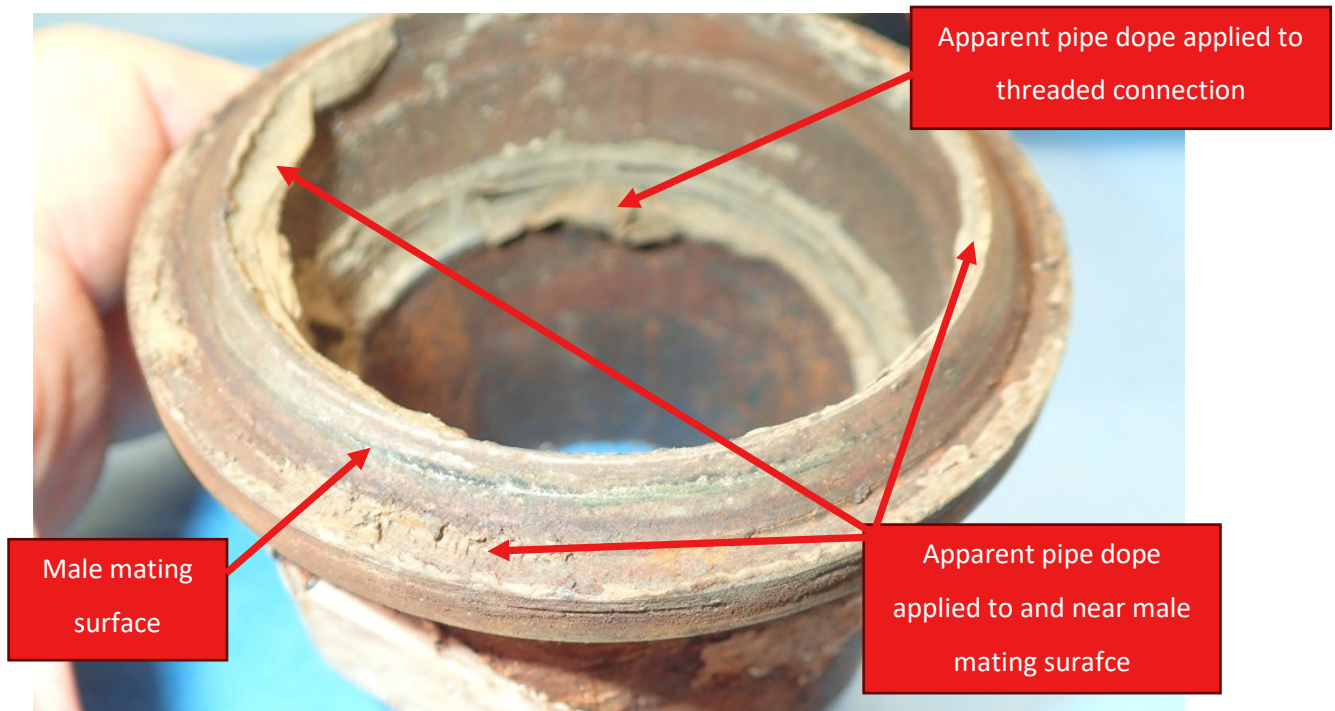
Figure 27: Male end mating surface.

Note, the mating surfaces on both the male end and female end appeared dull/unpolished. Scratching/polishing of the mating surfaces would be expected if the two mating surfaces had been wrench tightened to sufficient metal-to-metal contact and were loosened during the incident or at the lab exam.

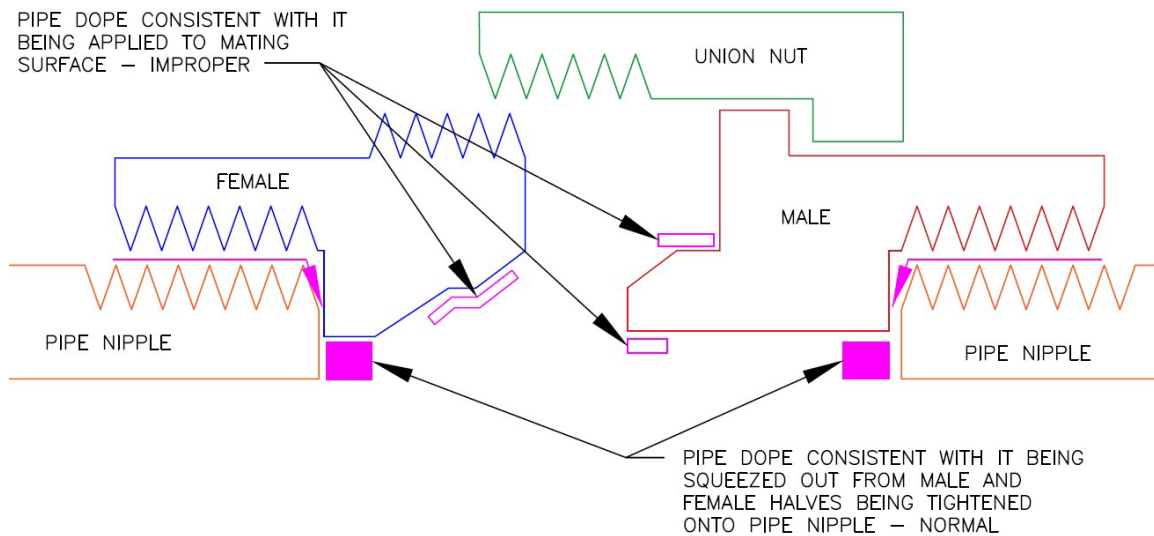
S-E-A created **Figure 28** to show an approximation of a typical union cross section, with the locations of the observed apparent pipe dope from the subject union. Note, Figure 28 is intended to be diagrammatical, and is not to scale.

**Figure 28: Diagram of typical union cross section with observed apparent pipe dope shown in pink.**

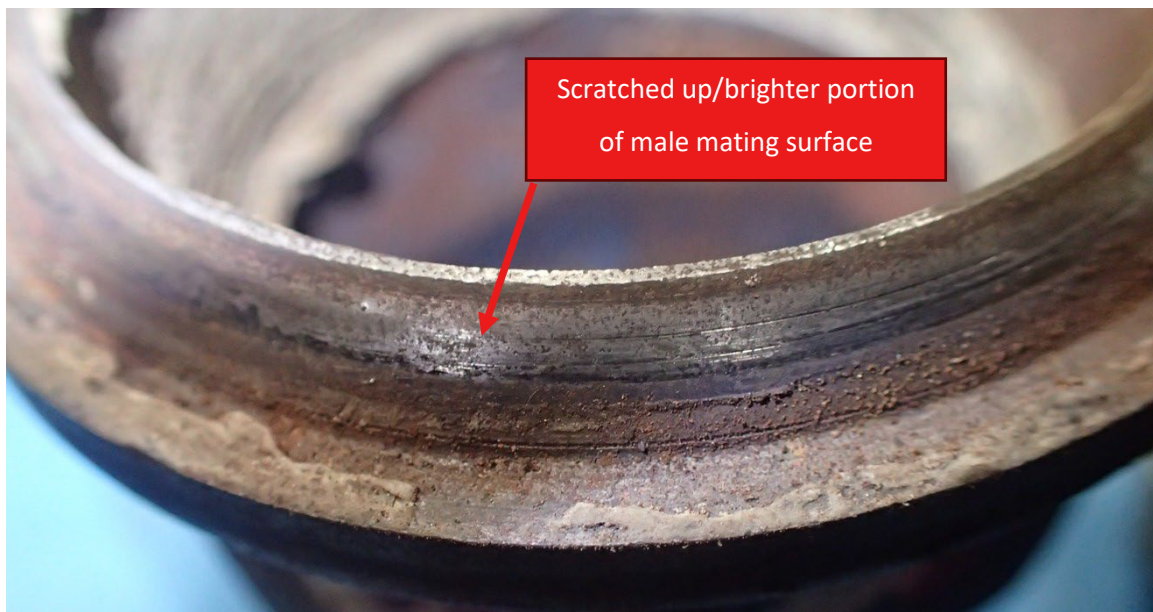
The union was then disassembled again to examine the two mating surfaces on the male and female ends. Inspection revealed that the previously dull mating surfaces were now scratched/polished, and pipe dope had been scraped away across a portion of the mating surfaces, causing them to appear cleaned/brighter, indicating that metal-to-metal contact had been achieved during the laboratory examination wrench tightening and disassembly (**Figure 29**).

**Figure 29: Male mating surface after reassembly to wrench tight and disassembly.**
