**SUBJECT: Executive Summary of Rainbow Terrace Investigative Efforts**

The investigation into the tragic incident that occurred on June 23, 2025, at Rainbow Terrace Apartments has been finalized.

The evidence does not establish the source of the gas release or the heat source that ignited it to the degree of certainty required under NFPA 921; accordingly, FIU classified the cause of the fire and explosion as **Undetermined**.

S-E-A, Ltd. did not reach a conclusion regarding the origin and cause of the explosion. However, **Enbridge concluded that the “apparent cause” of the explosion was ignition of leaking gas from the building owned 2” house line gas piping.**

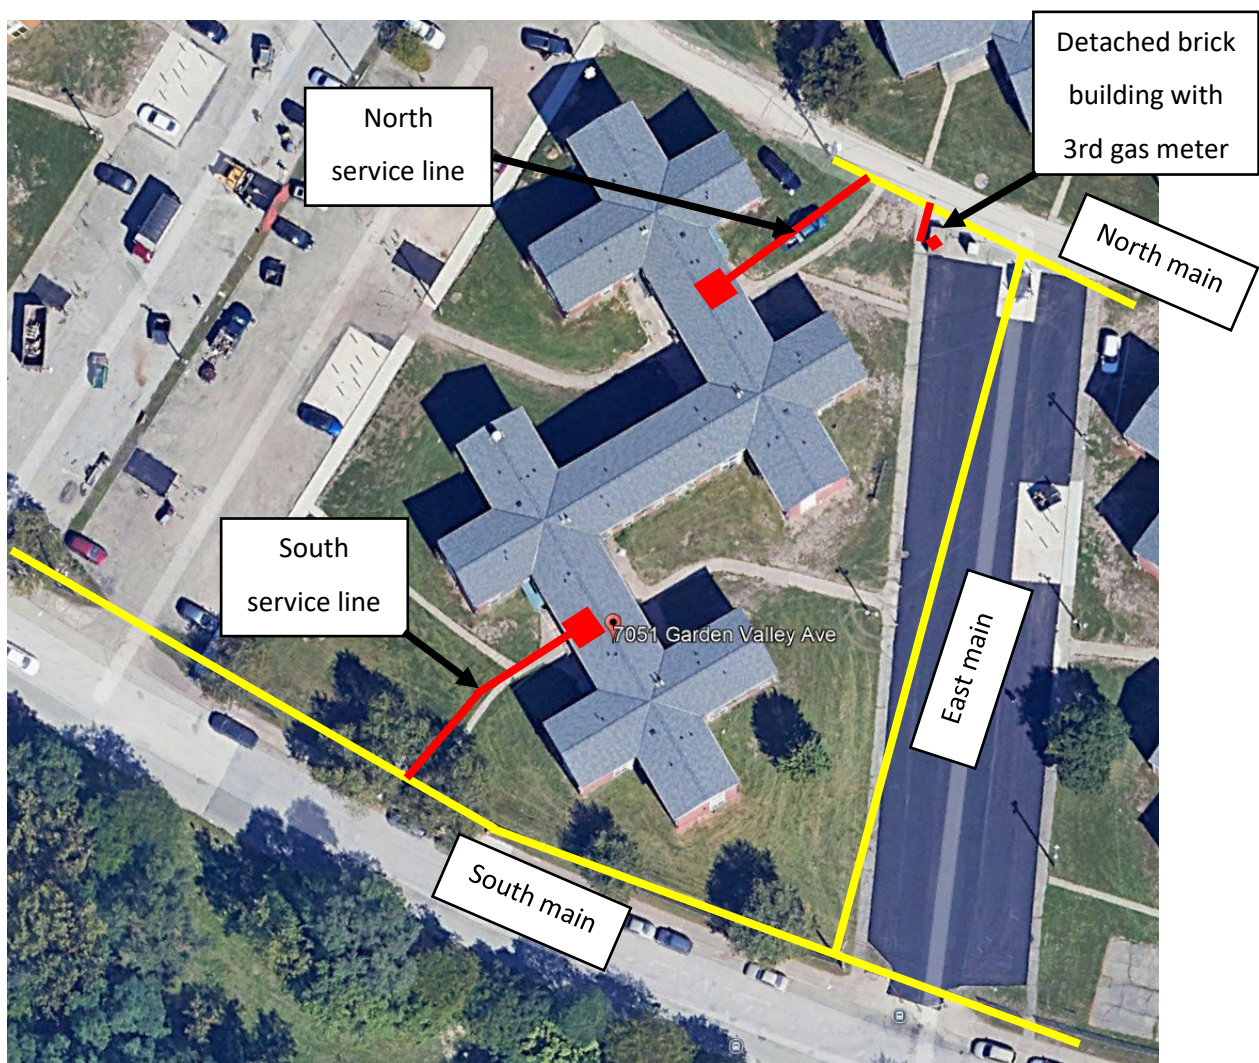
**Figure 5: Satellite image with approximate locations of natural gas mains and service lines overlaid.**

Enbridge Gas personnel reported to S-E-A that a gas main line, running east-west, was located below grade to the south of the building, and another east-west gas main line was located below grade to the north of the building. The east-west running mains reportedly operated at seven ounces per-square-inch of pressure ("ounces" hereafter) equivalent to 12.1 inches of water column ("w.c."). A service line was connected to the south main, and was routed underground (south service line) to a gas meter inside a first-floor south utility room. Similarly, a service line connected to the north main and was routed underground (north service line) to a gas meter inside a first-floor north utility room. A small, detached brick building, near the north-east corner of the building, housed a third gas meter; however, that third gas meter served separate apartment buildings to the north, but not the subject building. At a subsequent inspection (discussed later in this report), it was confirmed that the natural gas mains to the north and south of the building were connected by a north-south running main to the east of the building (east main), see **Figure 5**.

In Figure 5, the yellow lines represent the natural gas mains, the red lines represent the service lines, and the red squares represent the natural gas meters. The locations and routing shown are approximate and not intended to be exact.

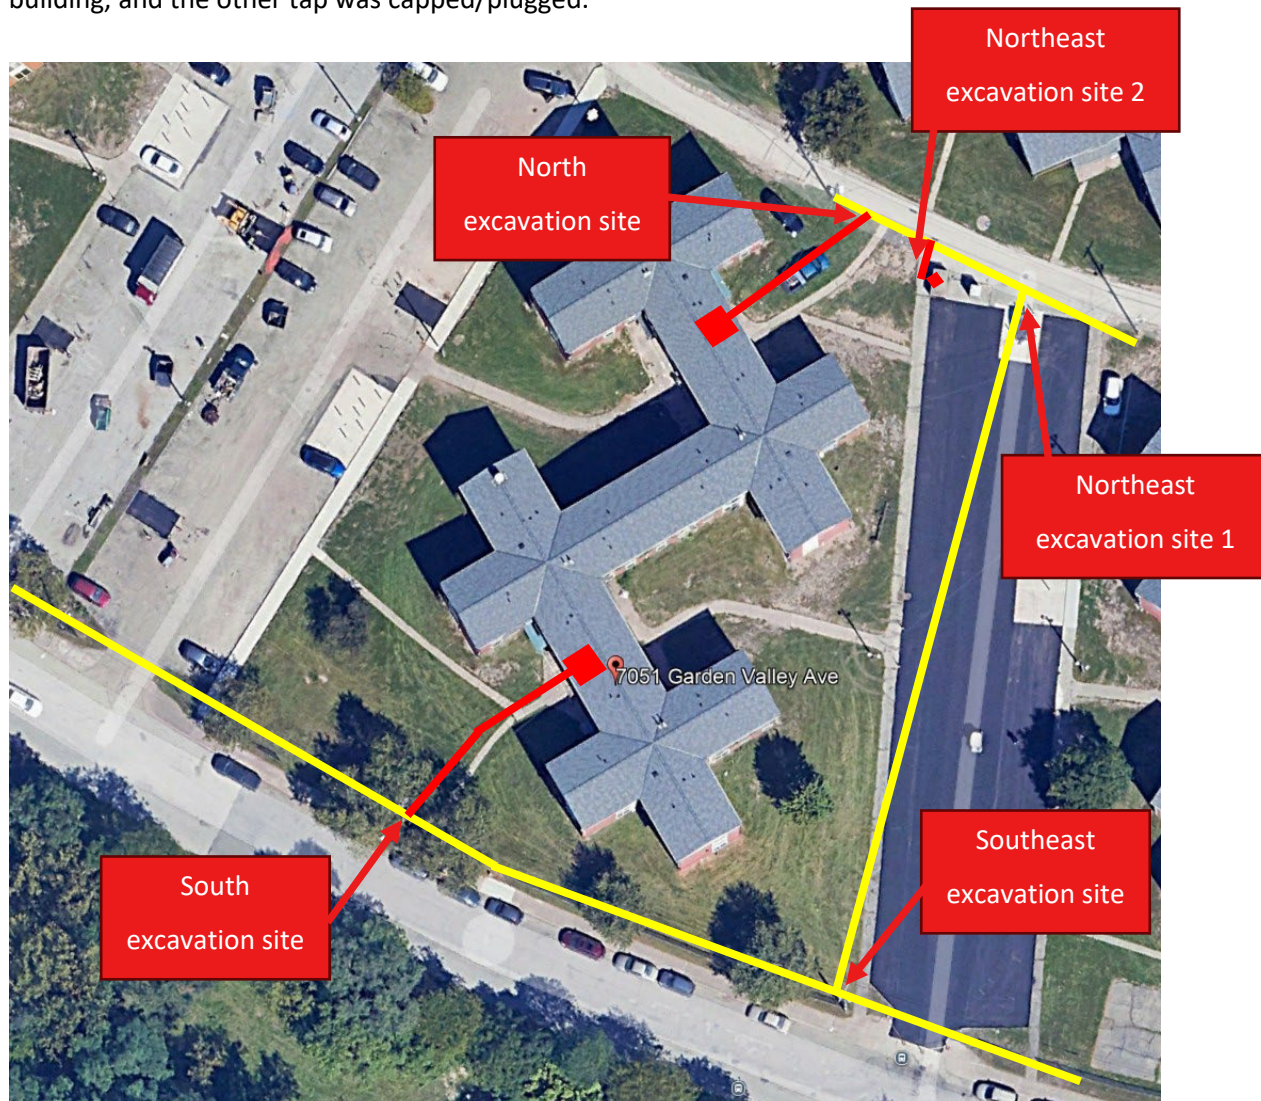
Figure 11: Excavation sites for borescope activities.

Enbridge Gas personnel re-excavated the east-west-running north main, where the north service line had been previously connected. Enbridge Gas personnel inserted a borescope camera into the north main, where the north service line previously connected (north excavation site in Figure 11), and sent the camera west approximately 2' before it was discovered that the north main was capped at that location. No anomalies were observed.

Enbridge Gas personnel inserted a borescope camera into the north main, where the north service line previously connected (north excavation site in Figure 11), and sent the camera east. Two taps were observed near the detached brick building at the northeast corner of the lot. Additionally, the north-south-running east main was observed.

Enbridge Gas personnel excavated where the north main connected to the east main. Enbridge Gas personnel inserted a borescope camera into the east main, where it was connected to the north main (northeast excavation site 1 in Figure 11), and sent the camera south approximately 175'. No anomalies were observed.

S-E-A participated in a joint scene examination on August 26, 2025. The two taps in the north main near the detached brick building at the northeast corner of the lot were revealed (northeast excavation site 2 in Figure 11). One tap fed the gas meter within the detached brick building, and the other tap was capped/plugged.

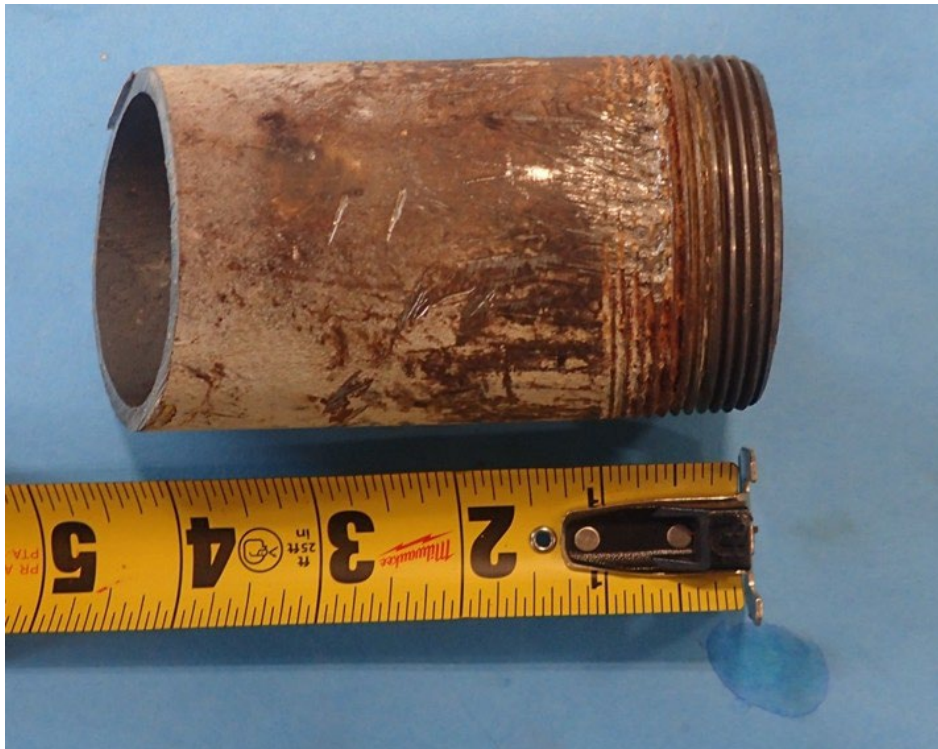
**Figure 12: Evidence #1 - south service line, pipe nipple downstream of valve just inside wall.**

- Evidence #1: South service line, pipe nipple downstream of valve just inside wall
  - **Figure 12:** Parties present agreed not to test with pressurized air. The approximately 4"-long, 3"-diameter steel nipple was visually inspected. The nipple was unremarkable with no apparent leak locations, no major corrosion, and no observable anomalies present.

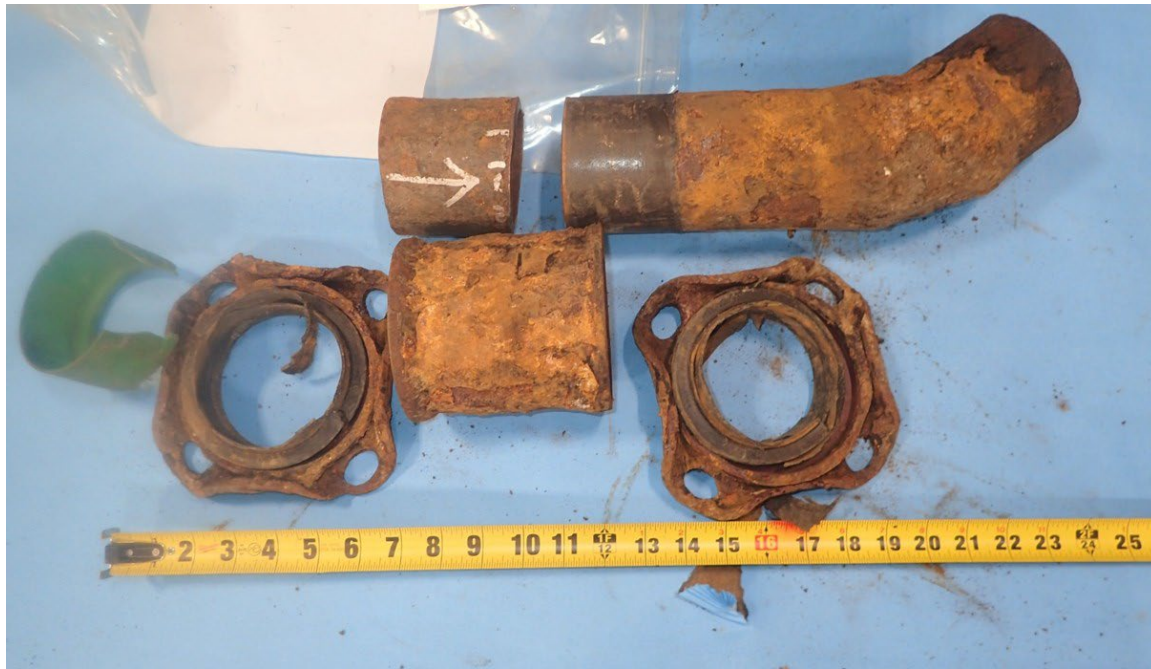
**Figure 13: Evidence #2 - south service line coupling near connection to main and elbow segment, and Evidence #6 - south service line, upstream end segment cut for pressure test.**

- **Figure 13:** Parties present agreed not to test with pressurized air as the installed location of the evidence was approximately 90 feet from the explosion area of origin, and the evidence was unremarkable with no observable anomalies present.

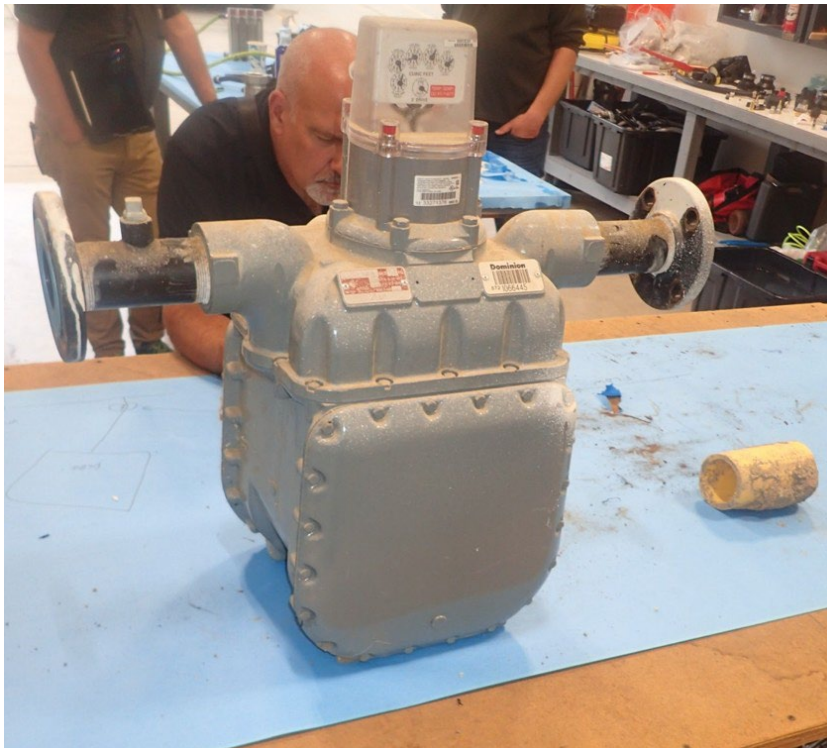
**Figure 14: Evidence #4 - north gas meter.**

- Evidence #4: North gas meter
  - **Figure 14:** Parties present agreed not to test with pressurized air as the installed location of the evidence was approximately 130' from the explosion area of origin, and the evidence was unremarkable with no observable anomalies present.

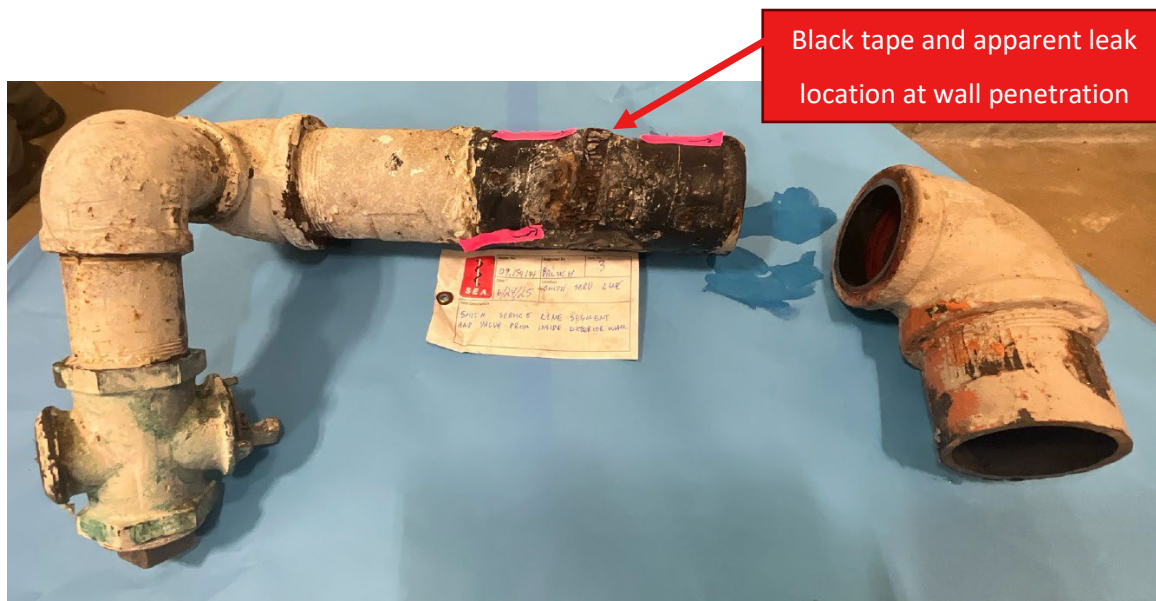
Figure 15: Evidence #3 - south service line segment and valve from inside exterior wall.

- Evidence #3: South service line segment and valve from inside exterior wall
  - **Figure 15:** The short 3"-diameter nipple and elbow (right side of Figure 15) were submerged in water and pressurized with air. No leaks were observed.

- The other portion (left side of Figure 15) of Evidence #3 was comprised of the 3"-diameter piping that penetrated the building's exterior wall (above grade), a reducing elbow, 2"-street elbow, 2"-nipple, and 2"-shutoff valve (refer back to Figure 6 for installed location and orientation). The portion of the piping that penetrated the exterior wall was found wrapped in a material similar to black electrical tape. The evidence was pressurized to approximately 12.7" w.c. (7.3 ounces) and a Dwyer flow meter with a 0.6 to 5.0 SCFH scale was utilized to measure a leak rate. No observable leak rate was detected and the "bead" on the flow meter did not rise. The evidence was

pressurized with air, then shut off from air, and it did not hold pressure, indicating a very small leak, less than 0.6 SCFH based on previous test with the flow meter. The evidence was submerged in water, pressurized with air, and bubbles appeared to emanate from underneath the black tape. The bubble locations were marked with pink tape for future testing.

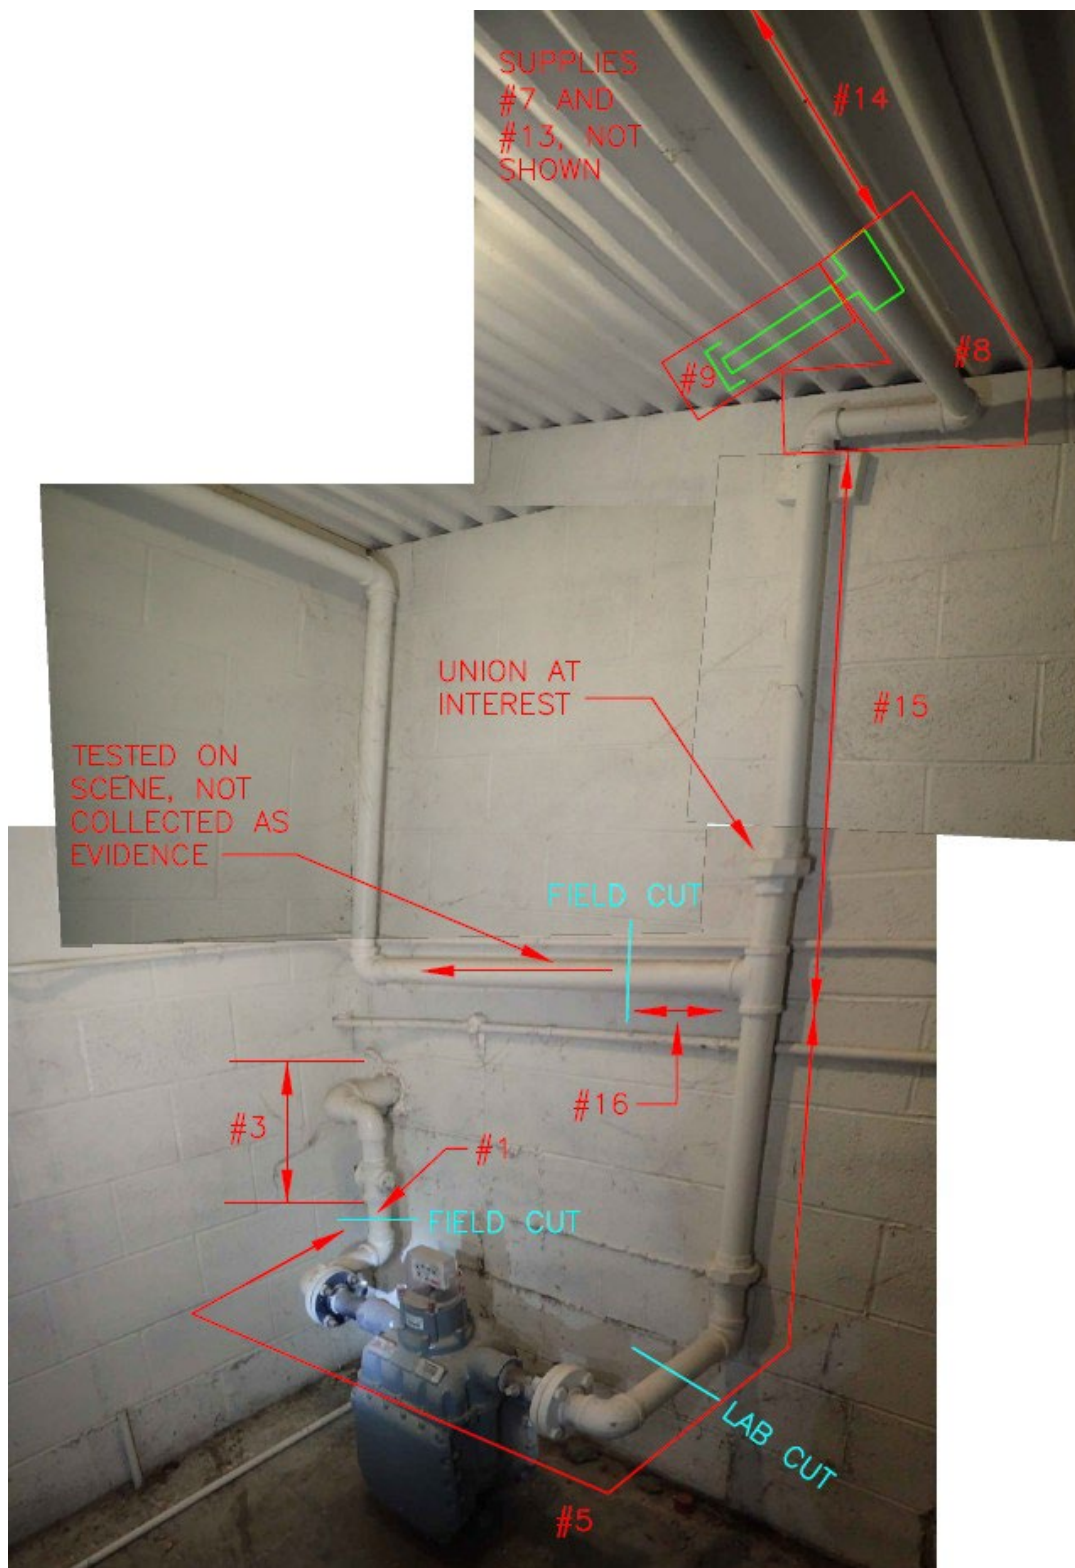
Figure 22: Evidence item locations on nearly identical utility room piping.

Parties present participated in matching up the various ends of the piping/fittings that had been collected as evidence. Preliminary matching appeared to show that all piping between the south gas meter and the two 2"-pipes supplying the two mechanical rooms was collected as evidence (i.e., no missing piping). **Figure 22** shows utility room piping from a nearly identical apartment building utility room, with S-E-A's evidence item numbers labeled.

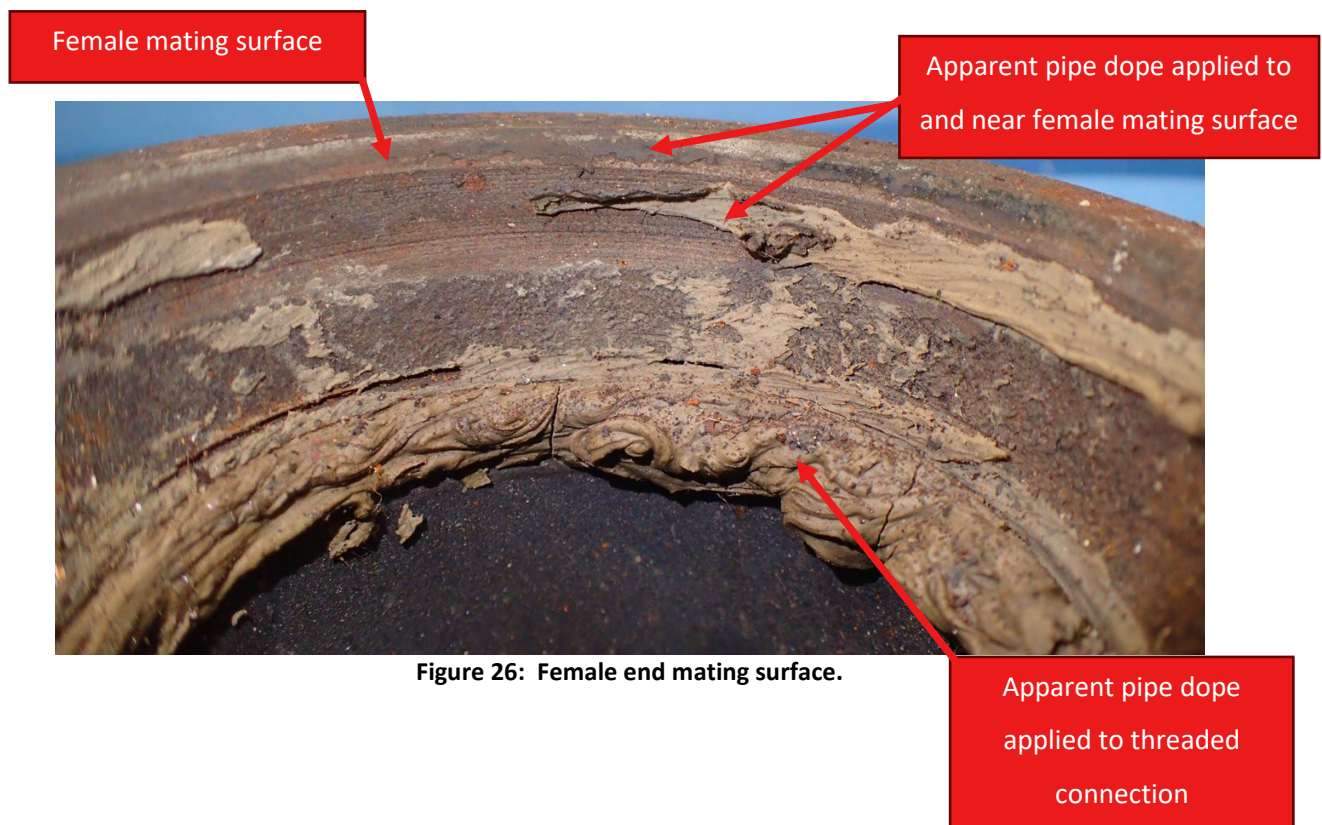
Figure 25: 2"-diameter union, disassembled, from Evidence #15.

Disassembly of the union revealed that the union nut was less than hand tight. It took five full rotations to disassemble the union nut, separating the two union halves. Threads on the union nut and male end were observed to be intact. Inspection of the mating surfaces of the male end and female end revealed that apparent pipe dope was used, likely during the original assembly, see **Figure 26** and **Figure 27**. Note, apparent pipe dope was also observed at the connection of the two union halves to the threaded pipe nipples, this was expected as pipe dope (or PTFE tape) should be applied to the threaded connections, but not at the mating surfaces of the union halves.
